NASA/TM—2002-211509

RQL Sector Rig Testing of SiC/SiC Combustor Liners

Michael J. Verrilli and Lisa C. Martin
Glenn Research Center, Cleveland, Ohio

David N. Brewer
U.S. Army Research Laboratory, Glenn Research Center, Cleveland, Ohio

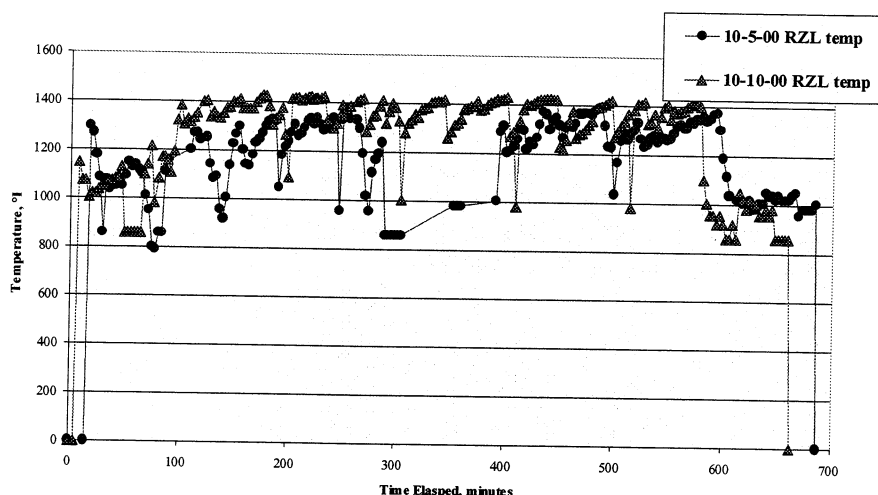
Figure 13 – Rich zone liner temperature measured during sector rig testing.

7.3.1 Fiber Optic Pyrometry Data – Figure 13 shows the temperature of a RZL versus time measured during two of the test runs. The temperature was measured 3.5 in. aft of the fuel/air nozzle and was obtained during the fourth and fifth test runs, when the second set of RZLs was installed. Note that the pyrometry system is not accurate below about 850 °F.

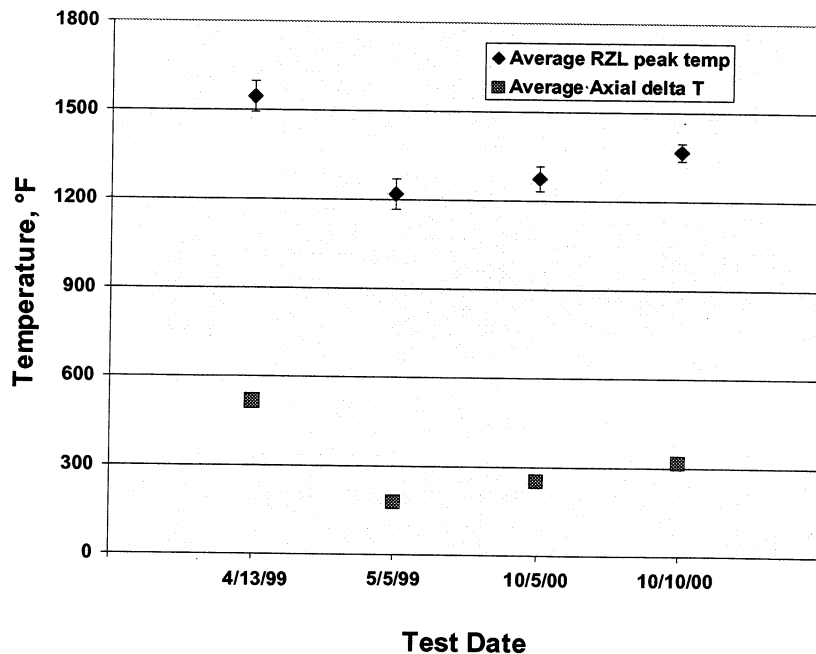
The average peak temperature measured during the supersonic cruise portion of the cycle is shown in Figure 14. Data obtained during the current study is shown along with some temperature data obtained during the previous 205 hours of testing. The maximum rich zone liner temperatures measured during the current study are within the range obtained during previous sector testing. Figure 14 also shows the axial temperature gradient, which is the difference between the average peak liner temperature and the combustor inlet air temperature, T3. The leading edge of the RZLs is cooled by the inlet air and therefore is at the same temperature. The axial gradients vary from 175 to 515 °F.

Figure 14 – Average peak temperature of rich zone liners measured during the supersonic cruise portion of the test cycle and calculated axial delta T as a function of test date.

The most critical aspect of material performance under the combustion environment is managing the thermal stresses (refs. 8–9). Liner temperature measurements indicated that a thermal gradient exists along the flow direction during operation (Figure 14). The gradient is based on temperatures measured along one linear section of the RZLs. It is likely that temperatures varied around the circumference of the liners, as a variation in oxide color (and therefore oxide thickness) was generally observed in tested RZLs (Figure 11). The presence of carbon deposits on the ID (Figure 12) likely affected the liner temperatures. Also, the thermal stresses, that are most important to design of the liners, are due to through-thickness temperature gradients. Thus, it is possible that the data in Figure 14 represents a lower bound for temperature gradients that would be critical to liner durability.

As part of this study, modifications of the fuel/air nozzles were made in an attempt to reduce the flow of by-pass air into the combustion stream and thus reduce the axial thermal gradient in the RZLs. The fuel/air nozzles contain seals that were designed to minimize the by-pass air flowing into the combustor. The presence of by-pass air in the combustion flow cools the upstream portion of the RZLs, but does not affect the temperature in the hottest portion of the liner, the aft end. This was verified with pyrometry data from tests conducted in 1999. The axial temperature gradients measured during tests conducted in 1999 bounds the gradients measured during the present study (Figure 14). Thus, the modifications of the fuel/air nozzles did not reduce the thermal gradients along the flow direction.

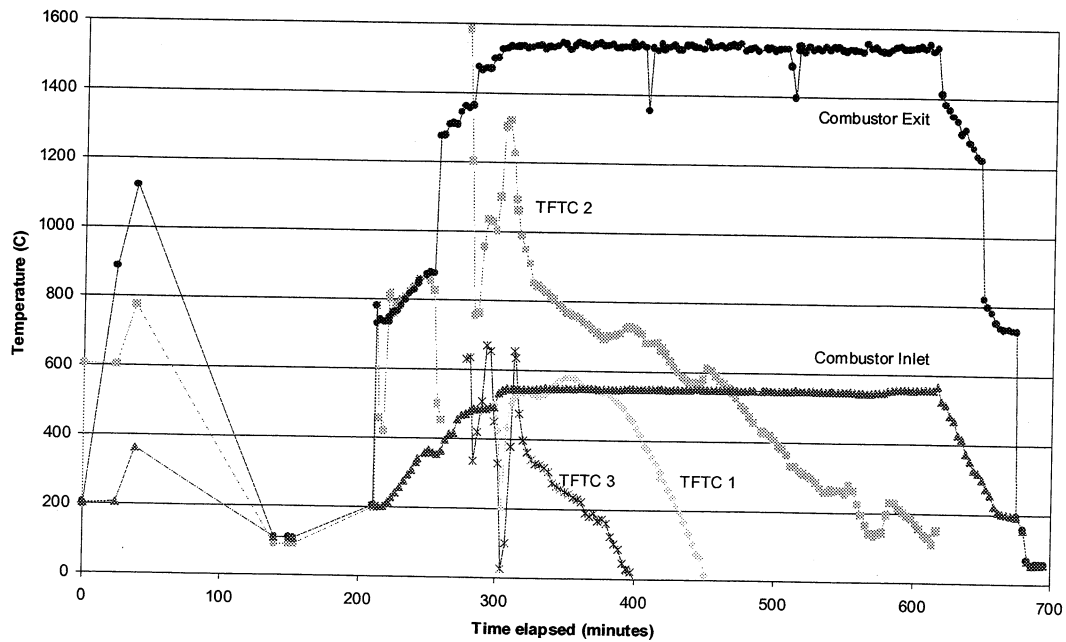
7.3.2 Thin Film Thermocouples – The RZLs instrumented with thin film thermocouples were exposed to room temperature air for approximately 220 minutes and heated air for approximately 210 minutes flowing about 2 lbs/s prior to the combustor being lit. This exposure was due to facility problems that prevented the initiation of testing. Only a few temperature data points were recorded during this period, however, the thin film thermocouple data obtained during this time indicated that the material surface temperature was between the combustor inlet and combustor exit temperatures. Once the combustor was lit, the thin film thermocouple output was erratic as the temperatures were increasing. The output of two thin film thermocouples and the combustor inlet and exit temperature data are shown in Figure 15. The thermocouple data eroded with time after exposure to the elevated temperatures.

Figure 15 – Thin film thermocouple data obtained during sector rig testing.

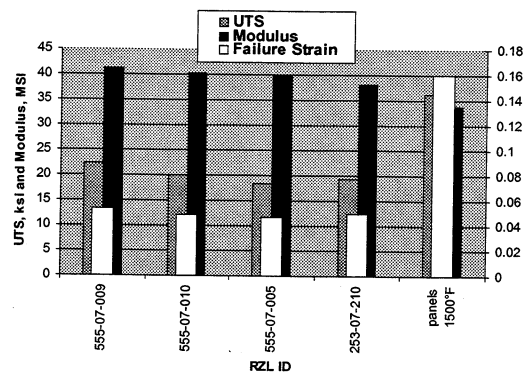
As part of the characterization of the as-manufactured RZLs, the hoop tensile properties were measured. A hydrostatic ring test facility was used to test two witness coupons from each component at room temperature (ref. 11). The strength, modulus, and strain to failure for the four rich zone liners are compared to data obtained from plate specimens machined from the same vintage material in Figure 17. On average, the rich zone liner witness coupons had 45% lower strength, 70% lower failure strain, and 20% higher modulus than the plate specimens. Thus, the properties indicate that the rich zone liner composite was more brittle and weaker than material in plate form. Note that panel data was the basis for the component design.

Quality of material may have contributed to the severity of damage observed. The as-manufactured components were ranked based on NDE results, mechanical and thermal properties from witness coupons, and microstructural quality. The highest rated rich zone liners were selected for initial rig testing. Three sets of RZLs (six total) were tested during the first 205 hours of sector rig operation in 1999. The first set failed catastrophically due to design issues with the attachment system. The other two sets of RZLs tested in 1999 did develop cracks, but had less damage (in terms of total crack length) and were tested longer (65 and 80 hrs) than those tested in this study. The four RZLs discussed in this paper were

Figure 17 – As- manufactured strength, modulus, and failure strain obtained through ring burst tests for the rich zone liners exposed in the sector rig.

ranked lower than the six tested in 1999. In particular, the last PL-side RZL (253-07-210) that failed (Figure 10) had the lowest rank of the ten.
